12 Solutions for Fixing Common TEV Problems

By Steve Esslinger — Senior Application Engineer of Supermarket Refrigeration

The purpose of this form is to cover the higher percentage problems and repair procedures of TEVs in supermarket applications.

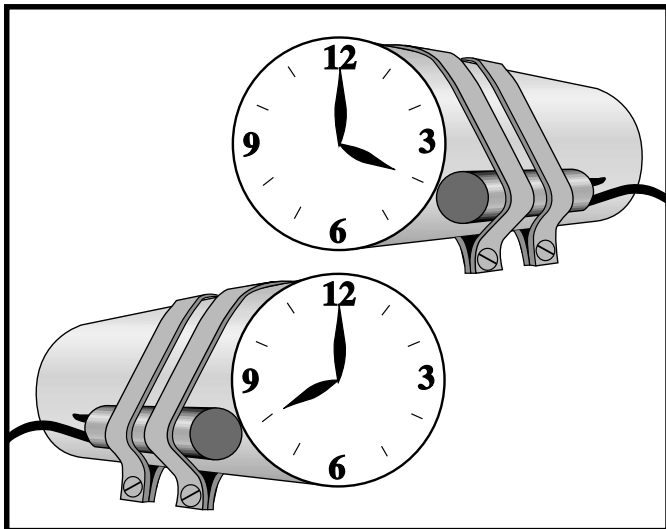
On suction lines 7/8" and larger, the sensing bulb should be installed at 4 or 8 o'clock on the side of the horizontal line.

2 — Check the Sensing Bulb Location: The sensing bulb should be securely fastened to a clean, straight section of the suction line. The bulb should not be influenced by ambient air temperature. The bulb should be attached to a horizontal suction line at the evaporator outlet. If the bulb cannot be located in this manner it may be located on a descending vertical line only. On suction lines 7/8" and larger, it should be installed at 4 or 8 o'clock on the
